3D Image Clinical Cases

Endodontics

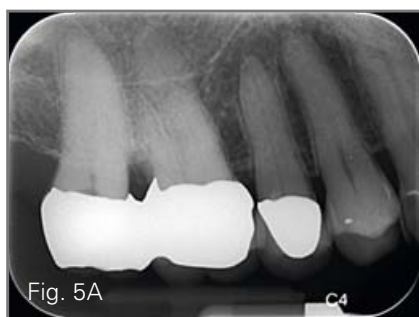
The patient presented below suffered from an irreversibly inflamed pulp in tooth # 2, confirmed by prolonged thermal responses to cold and heat. Conventional radiographs revealed a fused root structure with little or no information about the root canal anatomy (Fig. 5A).

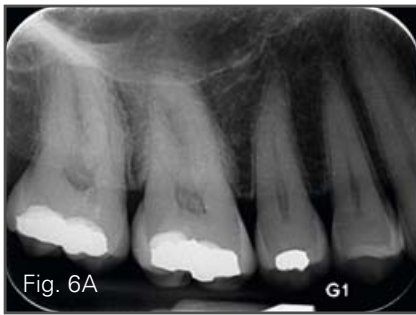
The patient presented with an irreversibly inflamed pulp in tooth # 3, confirmed by cold and heat testing (prolonged responses). Conventional radiographs revealed mesio-buccal root anatomy that was very curved, with the disto-buccal and palatal root anatomy appearing fairly straight (Fig. 6A).

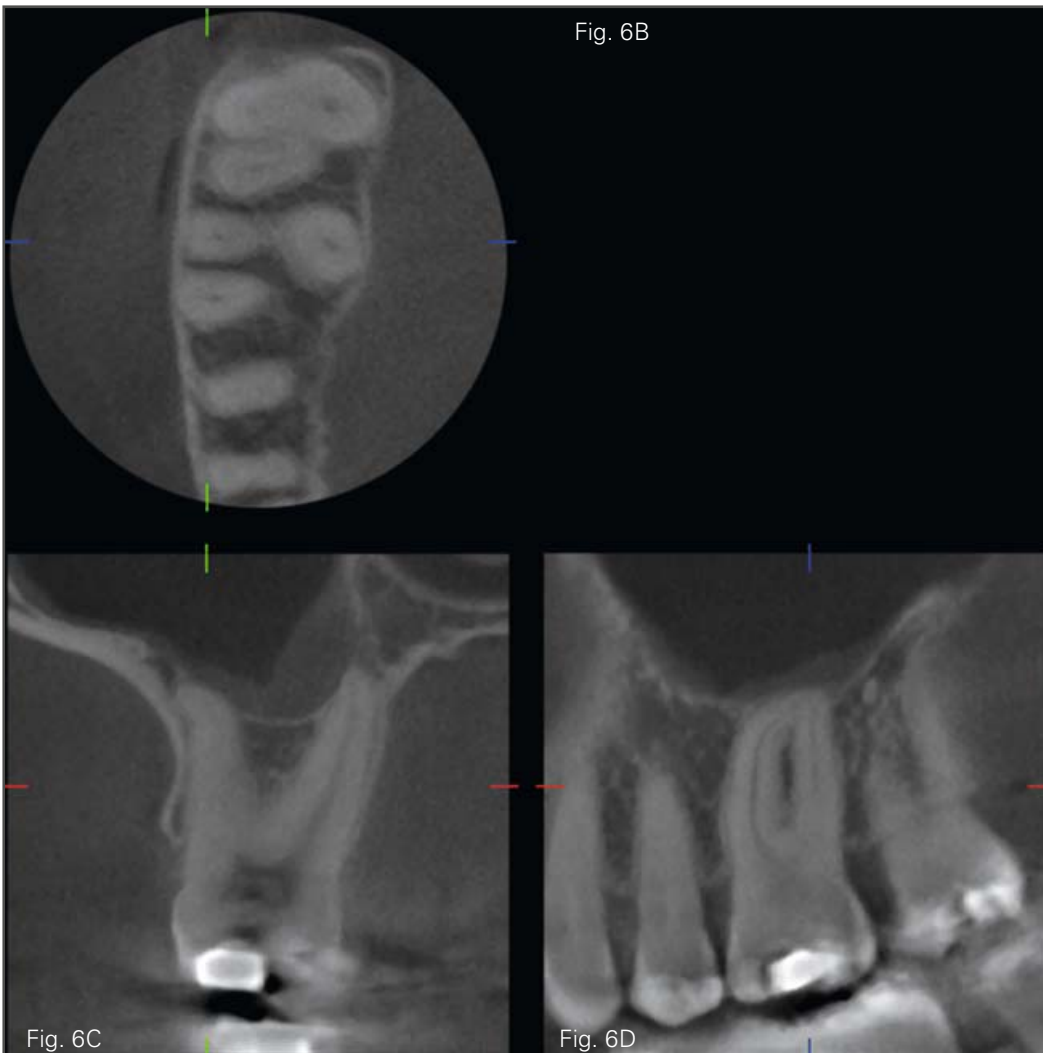
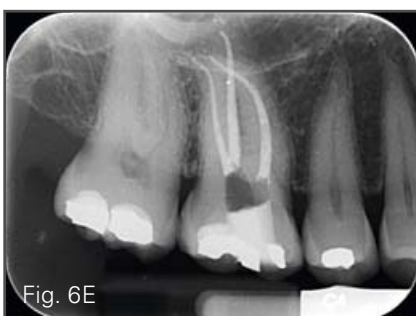
Accuitomo CT imaging revealed a different story, allowing me to tread carefully during treatment (Figs. 6B.). The first bit of important information was that this tooth unusually had only three canals (Fig. 6C).

The second piece of very important information was that the curvature of the mesiobuccal canal was truly awe-inspiring (Fig. 6D). The third piece of information saved my self respect and the patient's tooth from a broken rotary file, it revealed a severe canal curvature – in the normally-hidden buccal plane (Fig. 6E). Treatment, as a result was quick and sure with an exceptional (sorry, but it's true) result (Fig. 6E).

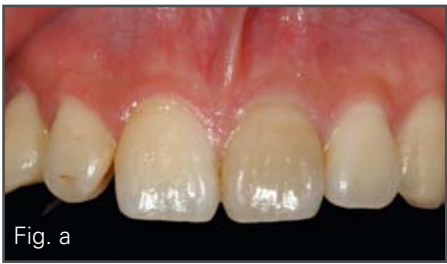
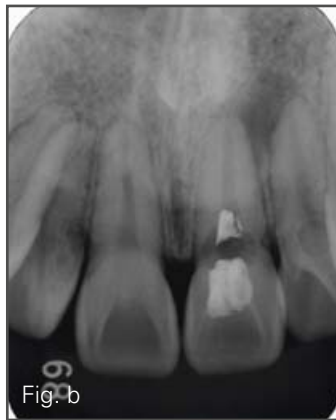
a./b. The first examination. A 20 year old male. The chief complaint was the discoloration of the crown of # 9 and slight pain. External resorption from the palatal aspect and LEO were found. He had an experience of subluxation of the involved tooth 3 years ago.

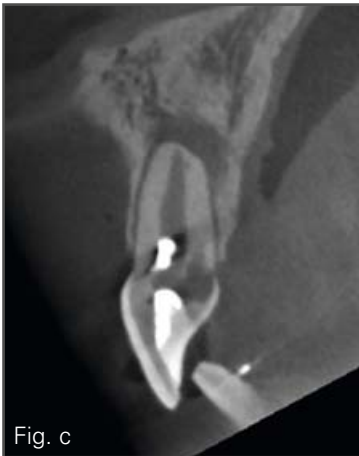
c./d. CBCT appearances. c: sagittal. d: axial. The root resorption start from the cervical area on the palatal aspect and invaded into the dentin.

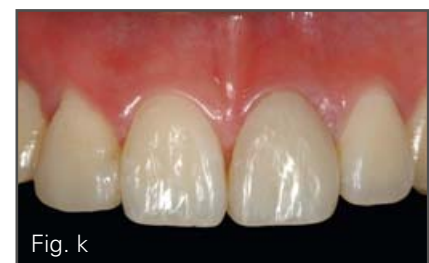
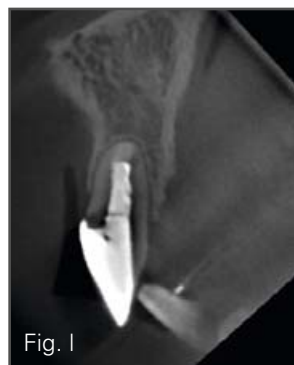
l. CBCT appearance 1 year post op. The PDL space and the buccal alveolar bone is nicely preserved. No resorption is observed. Interesting is that the PDL is formed over the retro-filling materials.

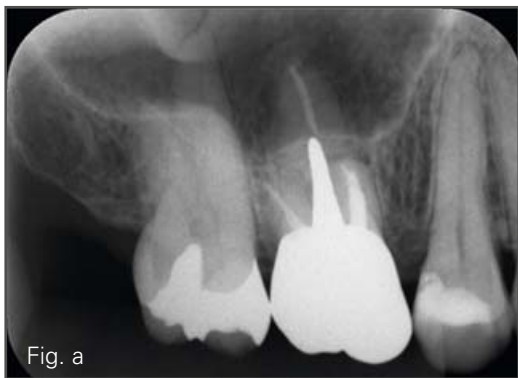
a.-f. Before treatment.
A 46 year old female.
The chief complaint is pain around # 3.

The bone of the sinus floor is badly resorbed and the Schneiderian membrane is thickened due to inflammation. The cause was considered to be the inappropriate canal treatment of the mesial root.

- a. Periapical radiograph
- b. Clinical view
- c. Coronal view of the mesial root
- d. Coronal view of the palatal root
- e. Coronal view of the distal root
- f. Sagittal view of the mesial and distal roots

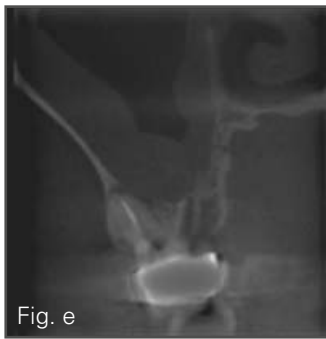
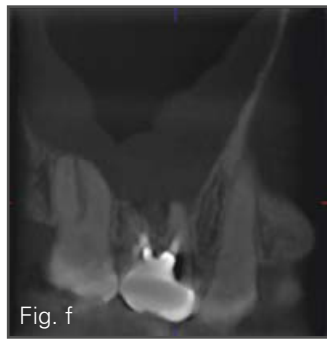
i.-l. CBCT appearance six months later. The sinus bone has come back and the Schneiderian membrane looks normal.

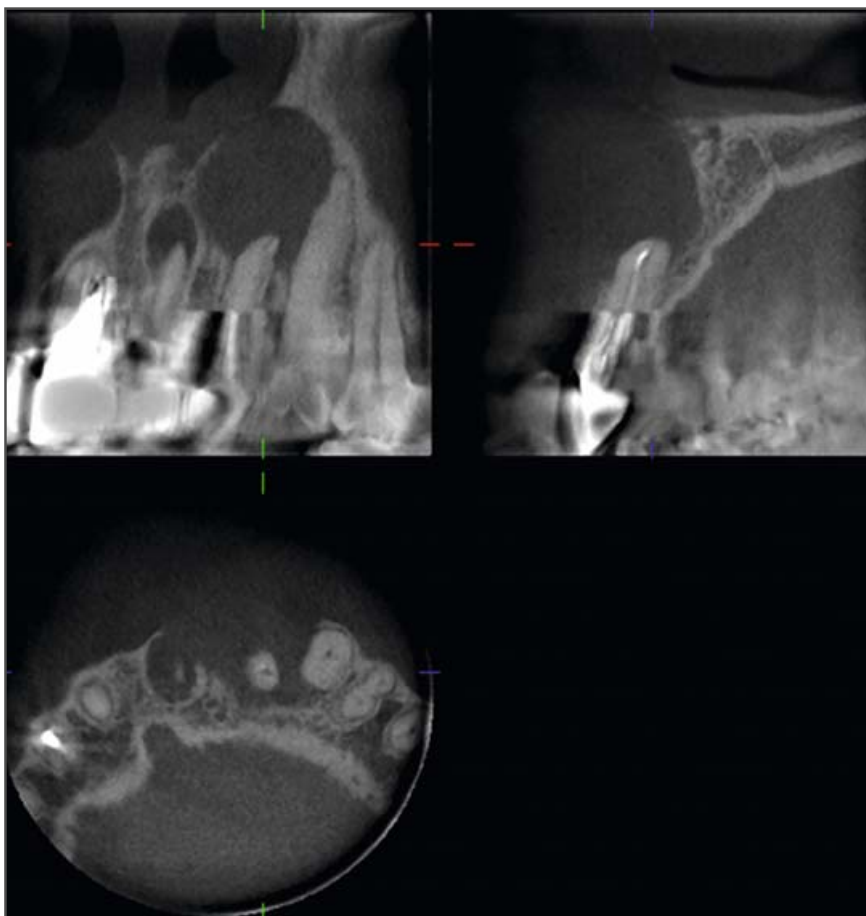
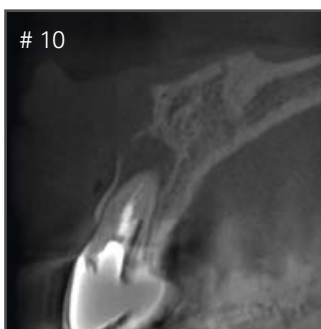
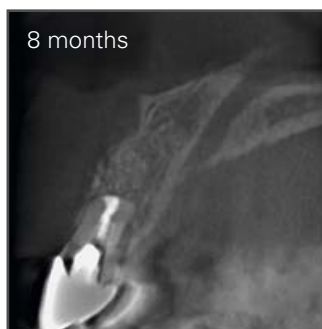
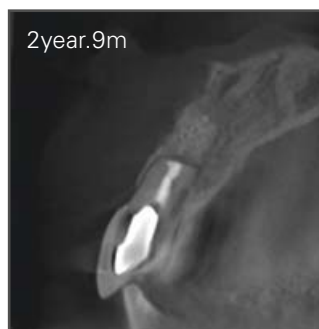
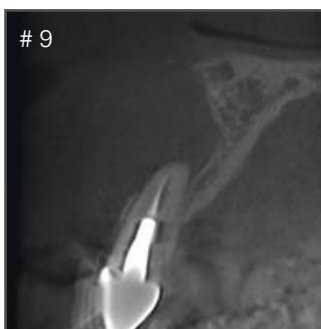
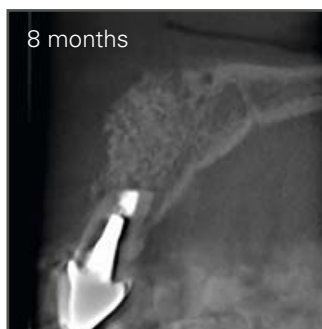
Apicoectomy and follow-up with CBCT.

A 41 year old female.
9 and # 10 suffer LEO and apicoectomy was indicated.

3 mm of each apex was cut off and the bony defect was filled with Bio-oss after the retro-fillings. The healing of the involved teeth was followed up with CBCT.

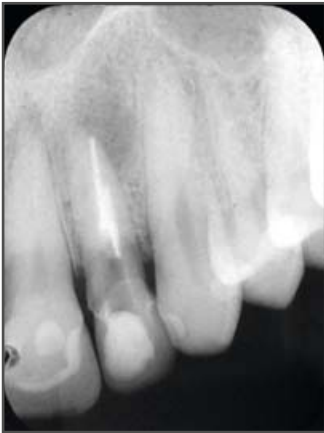
The periapical and panoramic radiographs show an “acceptable” endodontic treatment reaching the slightly lateral apex of tooth # 10. The endodontic filling lateral appears to be “doubled”, giving the impression of the presence of two canals. Ill-defined periapical radiolucency is noted slightly on the distal aspect of the apical third.

Cone beam images show that the gutta percha is perforating the facial aspect of the root and the buccal cortex. Some gutta percha is found in the canal but it is not reaching the apex.

Periapical radiograph is a 2D presentation of a 3D object; it collapses all the structures in the examined area in one plane. The image of the gutta percha is projected over the image of the root giving the impression of an acceptable treatment.

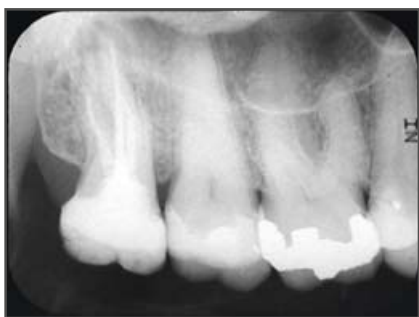
The periapical radiograph shows a well corticated, 3–4 mm periapical radiolucency onto the second molar. The tooth is endodontically treated and the endodontic filling material is homogenous, well condensed, and reaching the apex.

On the cone beam CT, the periapical lesion presence is confirmed with the presence of a severe vertical periodontal bone loss reaching the apex of the tooth in the form of what we call “endo-perio” communication. This finding was not seen on the periapical film due to the projection of the buccal and palatal thick cortical bones over the image of the periodontal lesion.

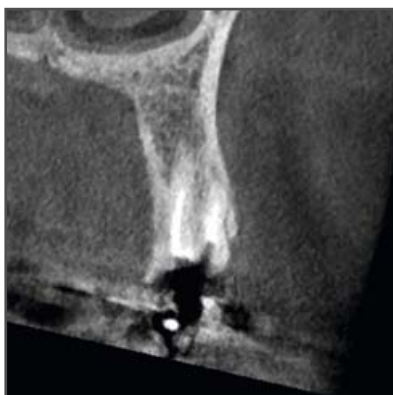
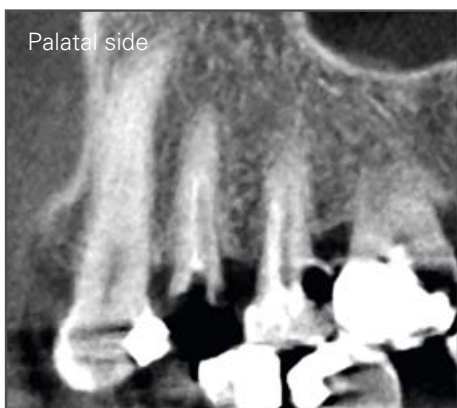
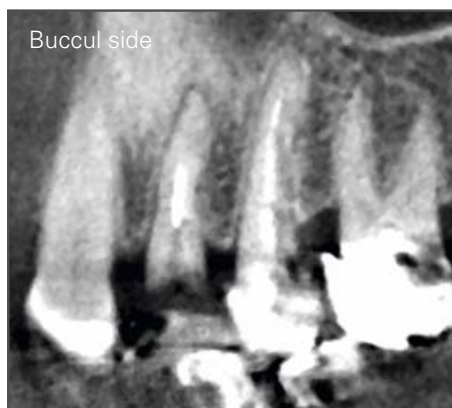
A Veraviewepocs 3D image shows an air-filled, healthy, maxillary sinus and a periapical lesion at the apex of the buccal root of the first premolar.

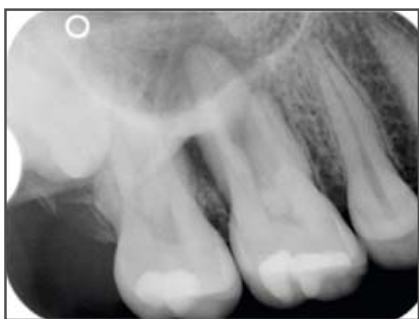
An endodontist had taken several images of the upper right molar region on a patient who presented with pain. He could see that a lesion was present at the first molar, but was uncertain about its extent.

The Accuitomo images showed a lesion with a very large extent in all directions. It has caused a break-down of both the buccal and palatal cortical borders. It extends into the lateral part of the nasal cavity and the lower part of the maxillary sinus where a reaction is seen in the mucosa. The lesion also involves the root system of the second molar and gets very close to the unerupted third molar. None of this could be anticipated from intraoral radiographs alone.

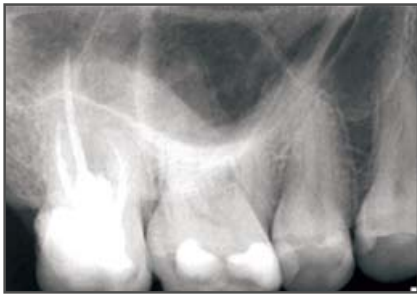
Although having taken several intraoral radiographs, an endodontist felt uncertain about the conditions at the upper right second molar from which the patient still felt some pain after an endodontic treatment had been completed.

The Accuitomo images show lesions at the two buccal roots and at a palatal root, but also that a second palatal root exists in which the root canal has not been treated. In addition, a lesion is seen in the interradicular area between the latter and the mesiobuccal root. The lesion at the buccal roots extends into the lower part of the maxillary sinus in which a thickening of the mucosa can be seen.

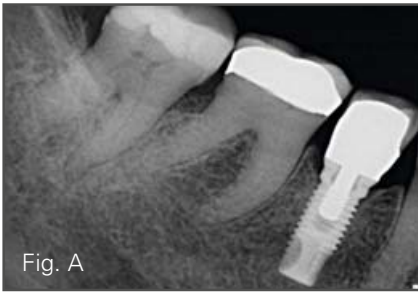
Clinical examination of the LR5, LR6 and LR7, revealed no abnormalities with no tenderness to palpation at the buccal and lingual root apices and no tenderness to percussion of any of the teeth. Vitality testing could not be carried out at the LR6 as the crown margin was subgingival. The LR7 predictably did not respond to the electric pulp test. The periapical radiograph (Fig. A) revealed widening at the periapex of the LR7 with no other signs of pathology.

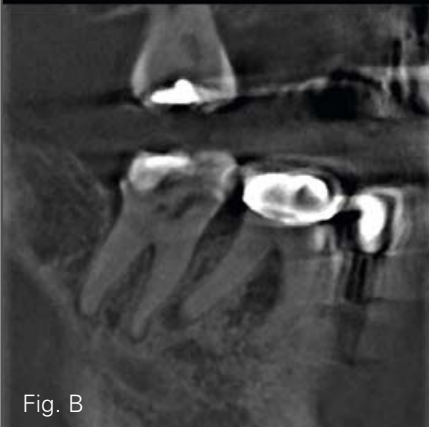
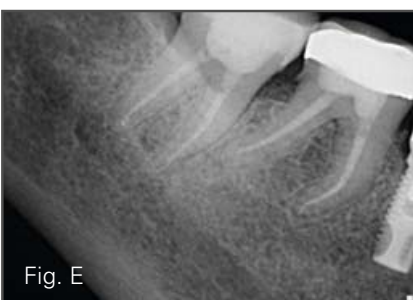
The sagittal slices of the microCT scan (Fig. B) however clearly showed a 4 mm circular lesion associated with the apex of the distal root of the LR7. The reason why this could not be seen on the periapical radiograph could be understood from the coronal slice (Fig. C) that shows the lesion positioned entirely in cancellous bone and not involving the cortical plates – the prerequisite for visibility on a standard periapical radiograph. Furthermore the anatomy of the root canals in the LR7 could be visualized with there being clearly one mesial and one distal canal (Fig. D).

Without the microCT scan provided by the Veraviewepocs 3D, an attempt would have been made to find another canal in the LR7, as there was no reason to treat the LR6. Significant damage to the root of the tooth would have occurred before the search would have been abandoned, and the patient would still have been in pain following the procedure. With the scan, treatment was initiated immediately in the LR6 and the pain quickly eased. Endodontic treatment of the LR7 when completed, was done without further damage in an attempt to locate a second mesial canal (Fig. E).

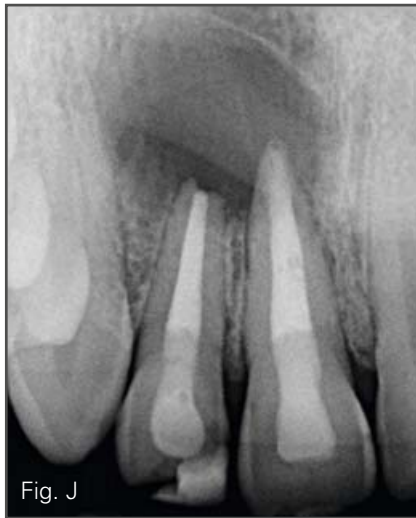
A 24 year old male patient attended 2 years following root canal therapy of his upper right central and lateral incisors (UR1 and UR2) with a draining buccal fistula (Fig. J). The teeth had been originally traumatised aged 10 and the apices were incompletely formed. On presentation with periapical infection aged 22 (Fig. F), the orthograde root canal treatments that were carried out had initially involved calcium hydroxide therapy followed by obturation with MTA apical plugs (Figs. G & H). Initial follow up at 6 months suggested some resolution (Fig. I), but the appearance of a fistula 18 months later confirmed regression and reinfection.

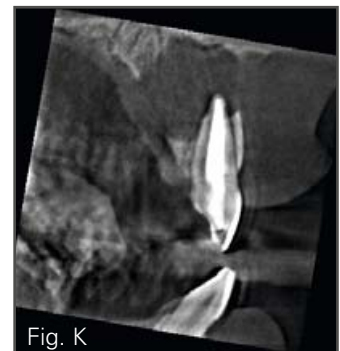
A microCT scan of the lesion using the Veraviewepocs 3D (Figs. K & L) revealed the true size of the lesion with both buccal and palatal plate perforations. The usual treatment of a recurrent periapical lesion with a satisfactory orthograde root filling would be buccal approaching periapical surgery with lesion curettage, apicectomy and possibly an apical retrograde seal. However, if this would have been carried out with such a lesion, soft tissue ingrowth from the palatal side would resist bony repair. True repair of a lesion of this size would require either a membrane on one side if the lesion to resist soft tissue ingrowth, or decompression followed by conventional surgery. Whichever is chosen, neither would have been immediately considered in a case such as this, and therefore, poor bone healing would have followed on from a standard surgical approach without the benefit of the microCT scan.

In this case a decompression procedure was carried out and a plastic drain was placed buccally (Figs. M & N) with the patient instructed to irrigate the underlying bony cavity with Corsodyl using a syringe. The drain stayed in place for 2 weeks and was then removed (Fig. O).

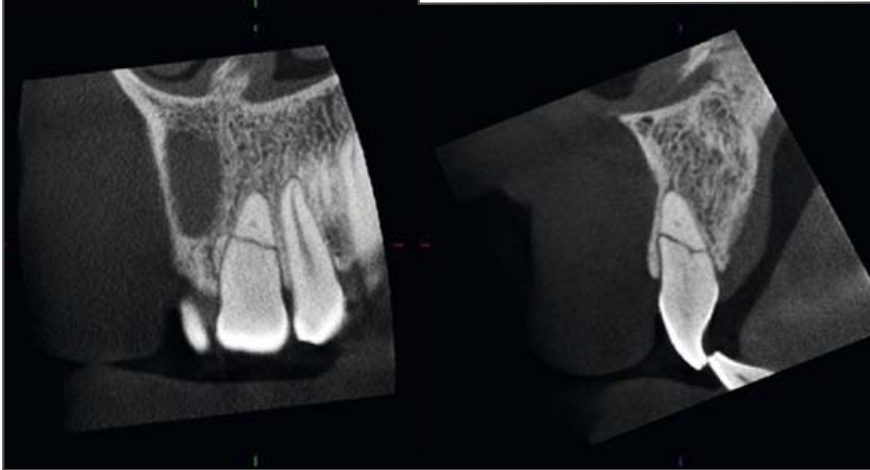
An Accuitomo examination of the upper frontal region demonstrates an upper right medial incisor with a very wide root canal. This can be seen in teeth that have become devitalized at an early age. At the apex of this tooth, a large cystic lesion can be seen. Its borders are not clearly defined and the surrounding bone is denser than normal. The lesion, thus, has the appearance of an infected apical cyst.

The examination also shows a fracture of the apical part of the right medial incisor.

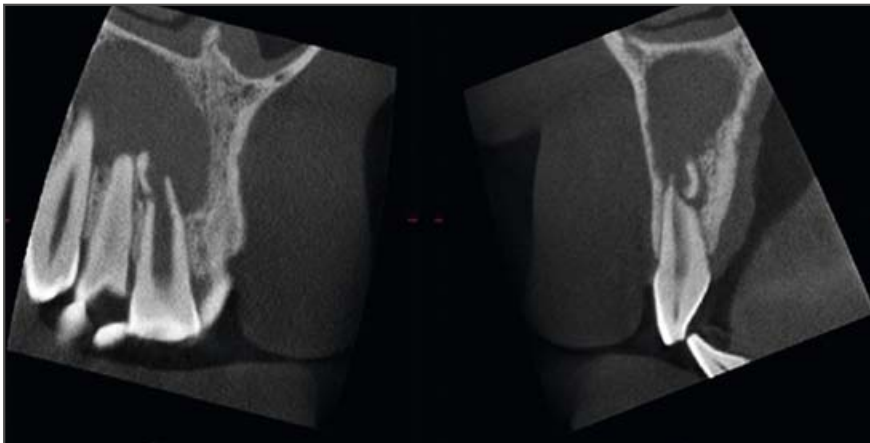
In the left medial incisor, an almost horizontal root fracture is seen. In both the apical and the coronal fragments, the pulp is almost completely obliterated.

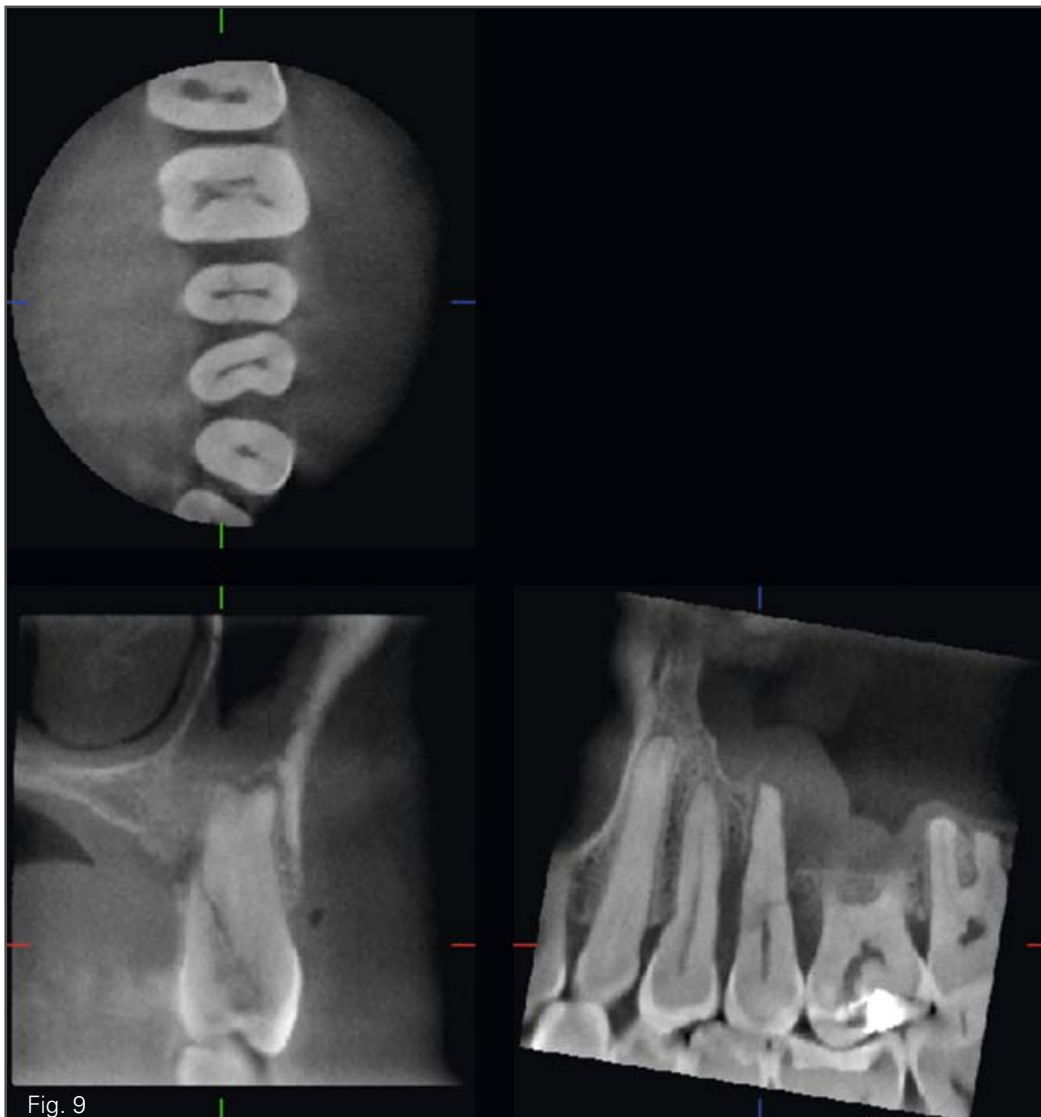
The Accuitomo scan (Fig. 9) clearly reveals an oblique fracture of the root of # 13 that extends from the palatal surface of the root towards the buccal surface of the crown of # 13. Interestingly, the fracture does not extend into the enamel, but appears to end at the area of the dento-enamel junction. There is also widening of the periodontal ligament space along the fracture line. Finally, there is thickening of the mucoperiosteal lining of the floor of the left maxillary sinus consistent with maxillary sinusitis, that most probably is unrelated to the dental disease described above.

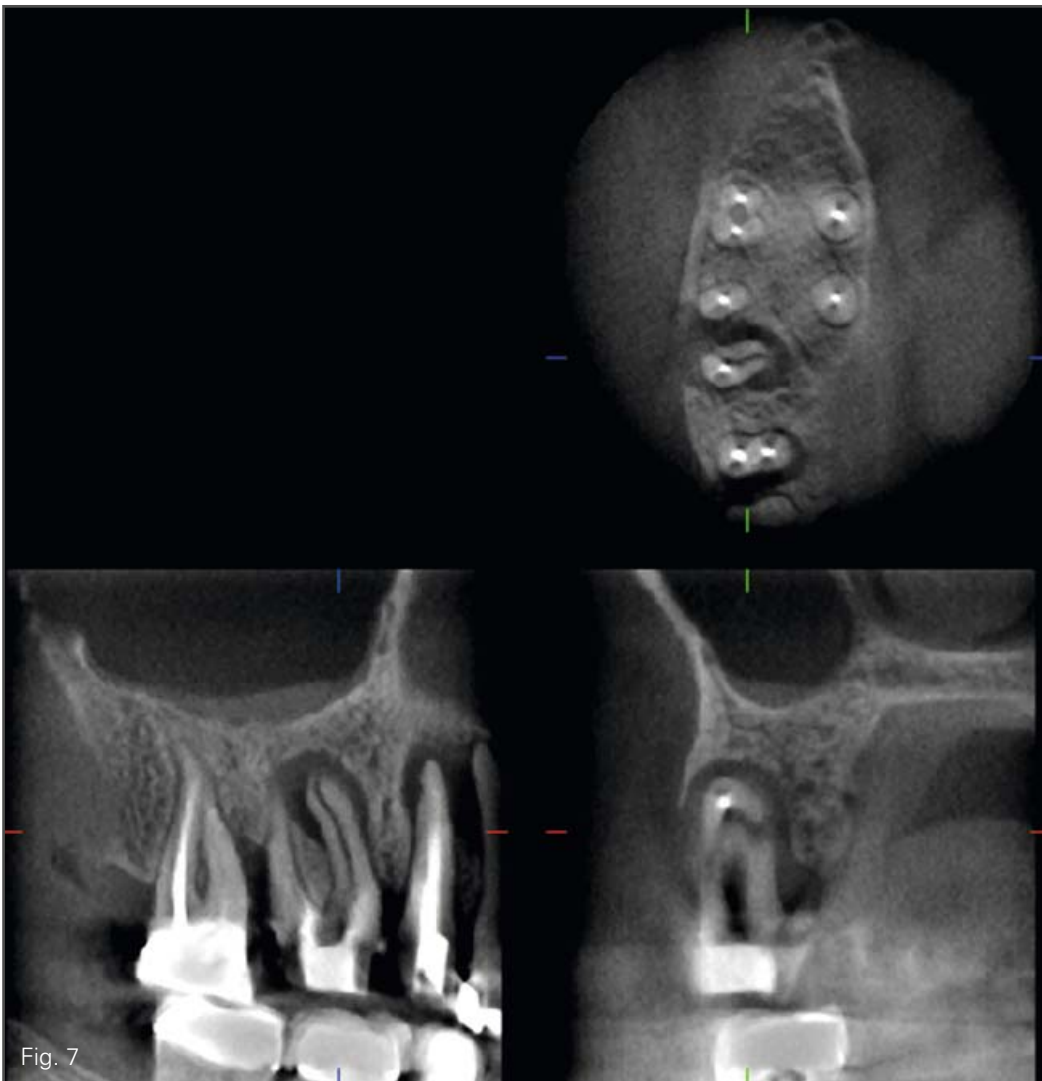
However, Accuitomo scan reveals a longitudinal root fracture of the mesiobuccal root of # 4 and extensive bone loss at the whole extent of the mesio-buccal root and destruction of the buccal cortex of the maxilla at the area (Fig. 7).

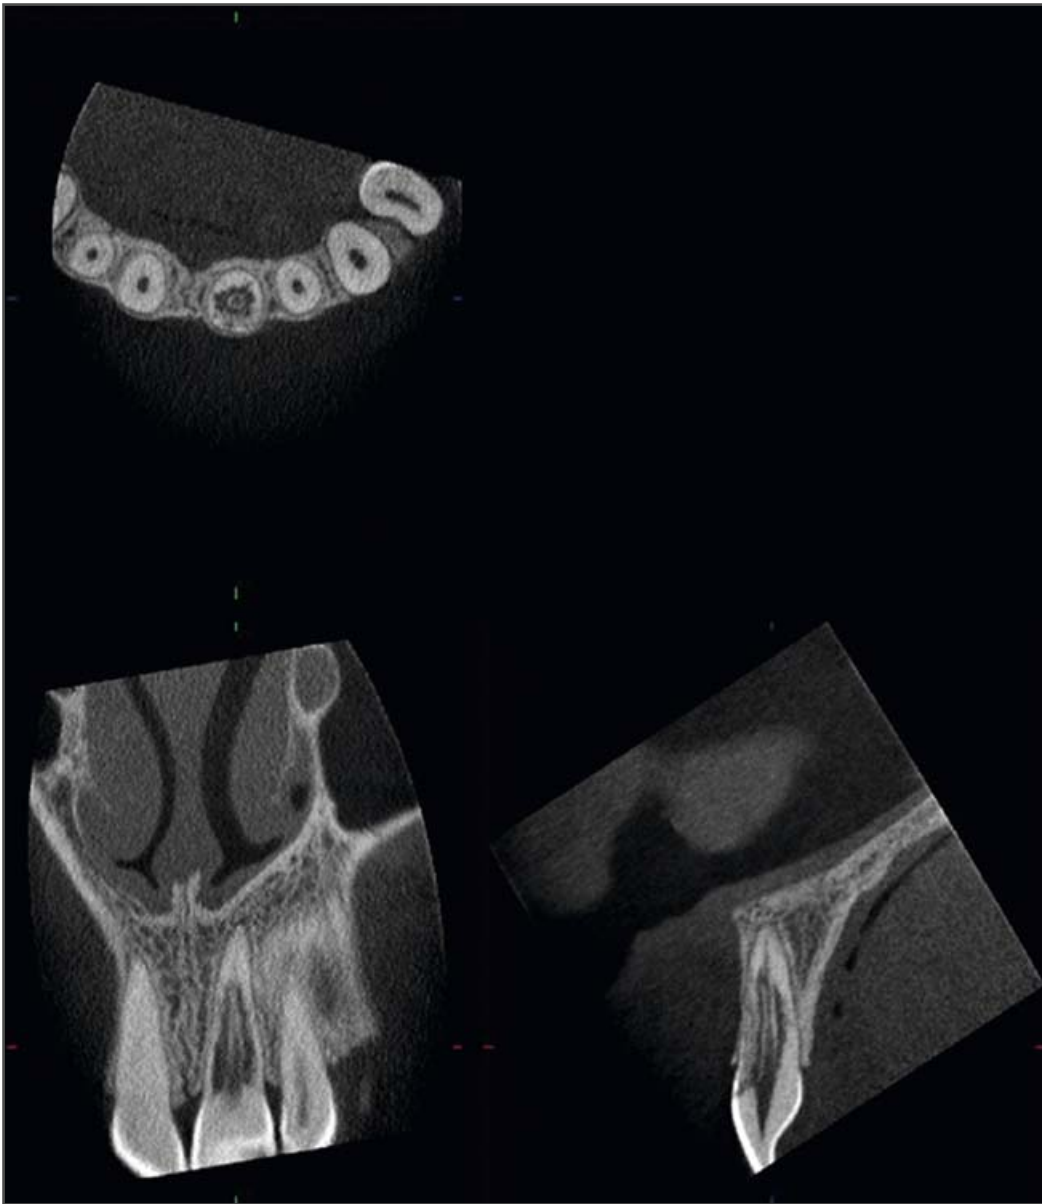
In a symptomless patient with known trauma to her upper left medial incisor several years ago, the Accuitomo examination shows a severely resorbed tooth. The images demonstrate the clarity with which resorptions now can be studied. Note that the walls of the pulp still remain and that there is a lack of buccal bone at the middle of the root. In all likelihood, the origin of this resorption is external rather than internal.

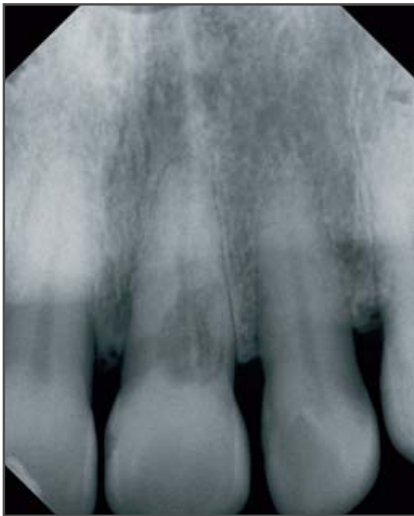
The first image is a traditional periapical film that shows the resorption superimposed over the pulpal space making it very difficult to determine the origin of the resorptive process.

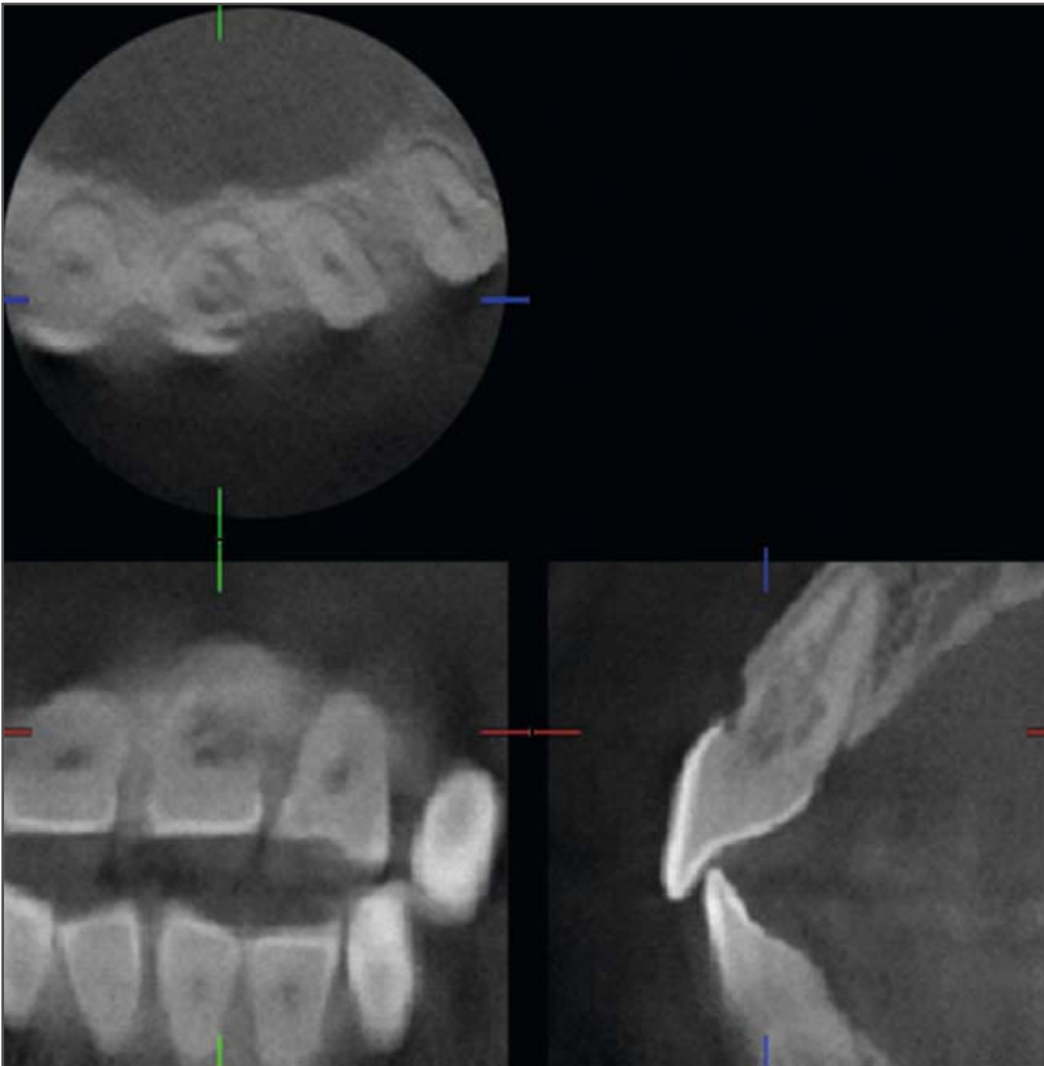
The 3D Accuitomo images make it very clear that we are dealing with a cervical resorption.

The cervical (external) resorption extensively invades tooth # 9. The process is highly destructive, yet it has not invaded the pre-dentin surrounding the pulp.

The 3D images clearly demonstrate a destructive process that makes the prognosis for tooth retention poor.

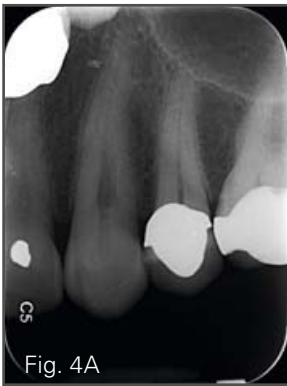
The patient presented with pain to palpation over tooth # 11. Vitality testing revealed that the tooth was vital. The conventional preoperative radiograph showed an unusual appearance of the root canal space just apical to the CEJ (Fig. 4A).

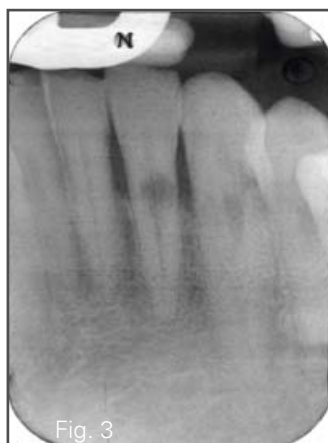
Fig. 3 shows the periapical radiograph of a 54 year old asymptomatic male patient. Panoramic and periapical radiographs taken during a routine dental examination, reveal enlargement of the pulpal cavity of teeth # 22 and 23, consistent with internal resorption. However, these radiographs do not offer any information regarding the extent of the resorption and thus do not aid in the treatment planning (i. e. endodontic treatment vs. extraction) of the patient. Clinical examination was unremarkable.
